Example Report

Prepared for Sarah Snag

Client	Sarah Snag
Instruction	26/08/2020
Address	27, Snag Close, Snagchester, SN3 AG
Builder	Example Homes
Development Name	Snag Tree Grange
Weather	Fair and sunny
Inspector	Phil Lucas
Inspection Date	19/08/2020

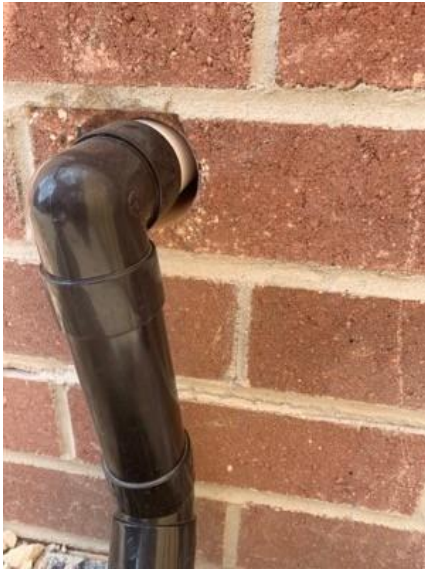
Snag 1

Continuous seal required around pipe outlet. Risk of infestation.

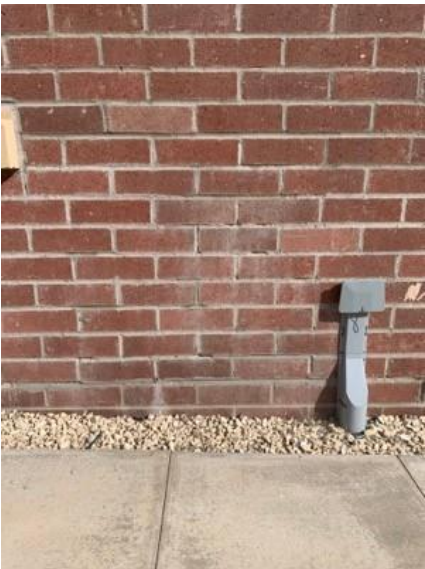
Snag 2

Make good pointing

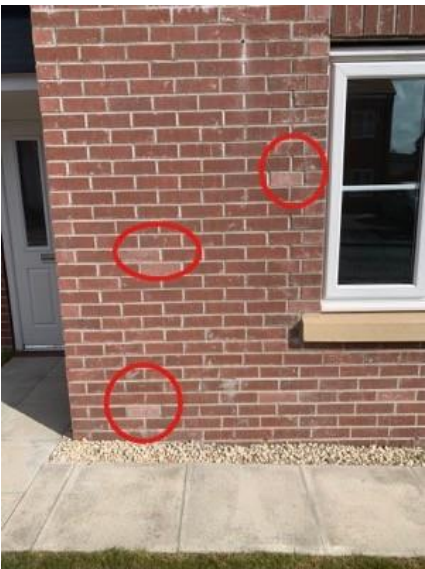
Snag 3

Inconsistent brick batch used

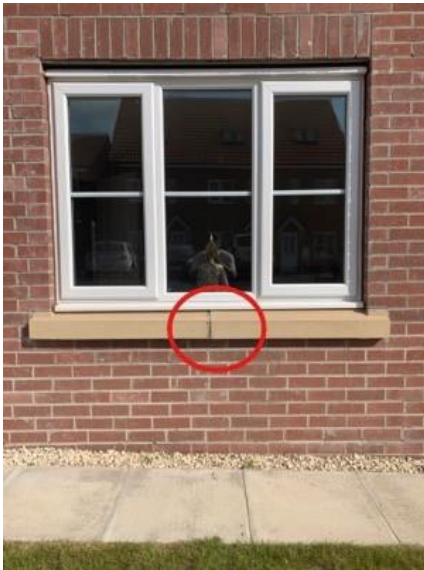
Snag 4

Make good at windowsill

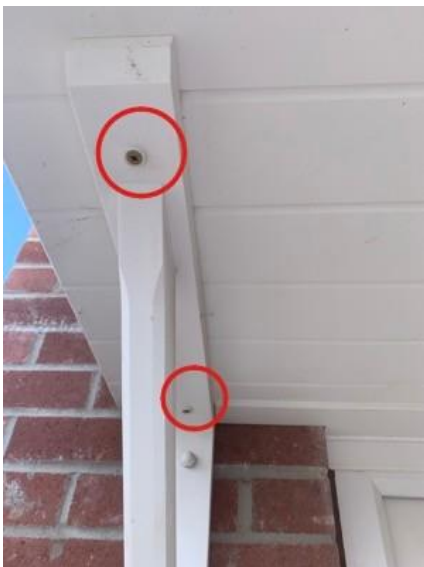
Snag 6

Screw caps missing

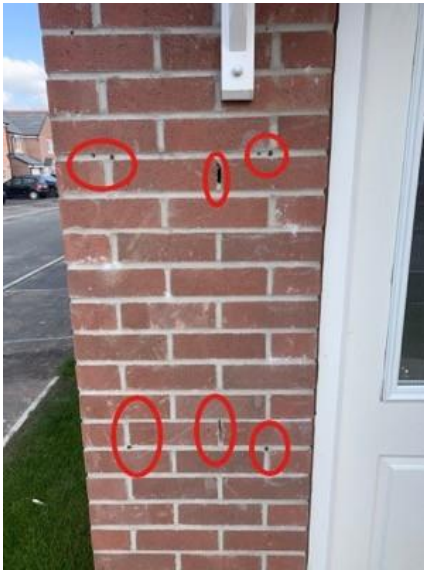
Snag 7

Make good pointing and remove nails

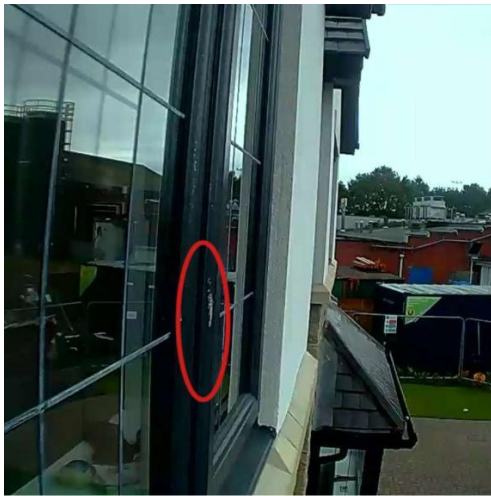
Snag 11

Render stain

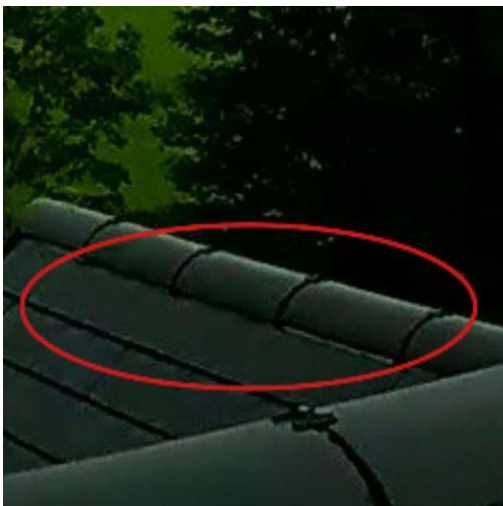
Snag 12

Roof ridging tile DPC
Inconsistent

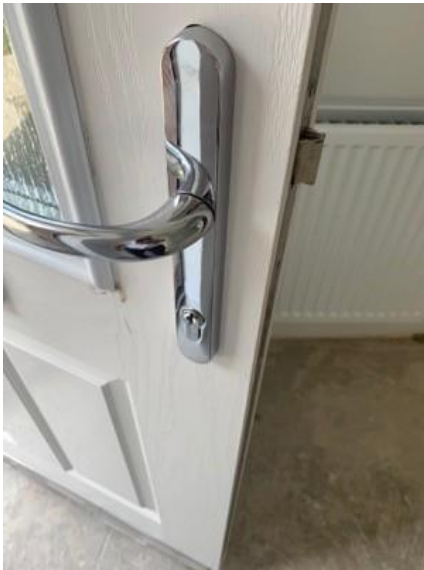
Snag 13

Incorrect key supplied, key not cut correctly or lock faulty

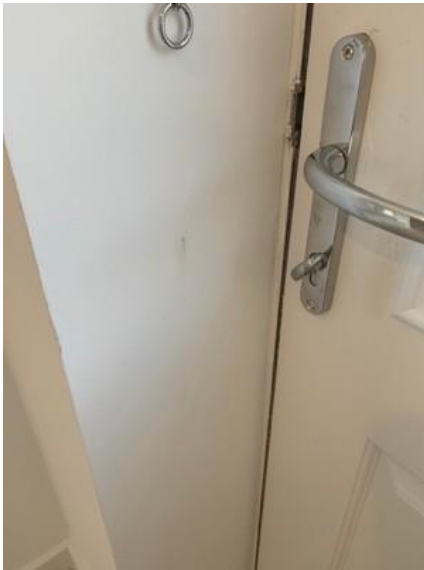
Snag 15

Scuff mark on wall

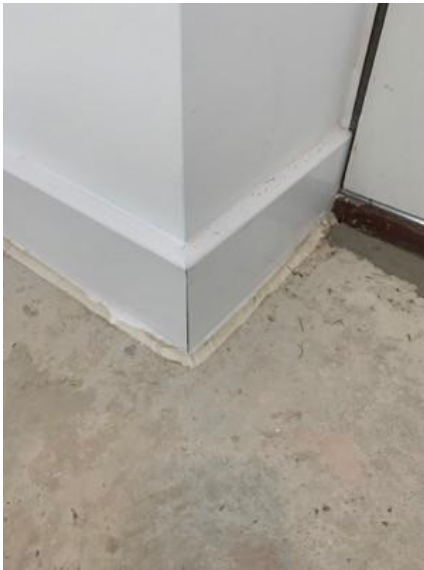
Snag 18

Make good at south east miter

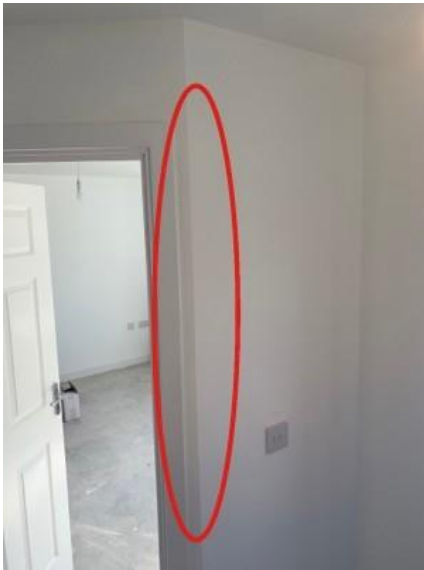
Snag 21

Inconsistent paint finish

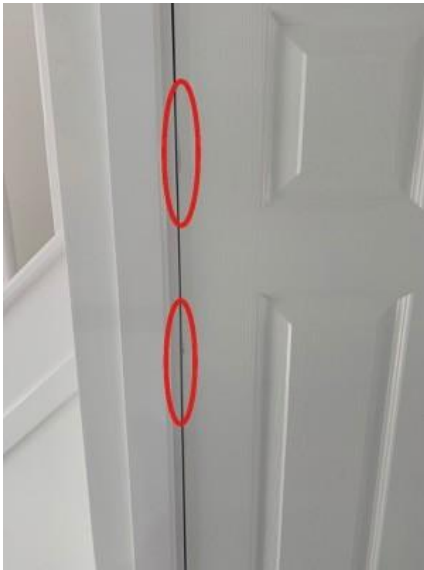
Snag 24

Make good paint finish on storage cupboard door

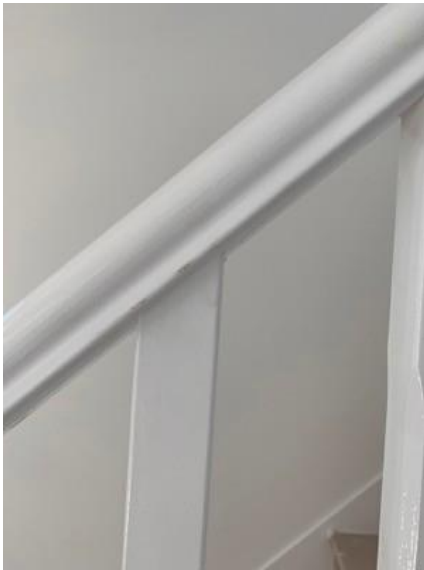
Snag 27

Scuff on banister

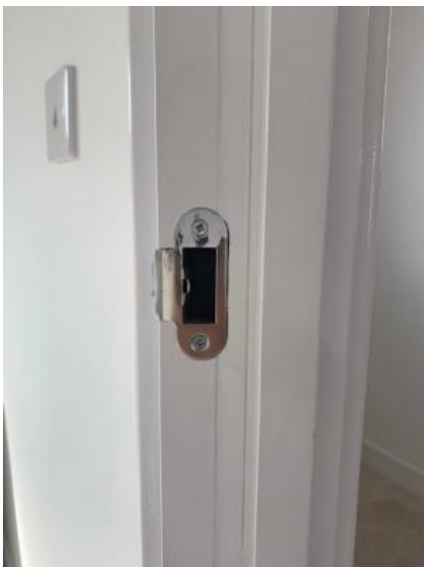
Snag 29

Excess paint

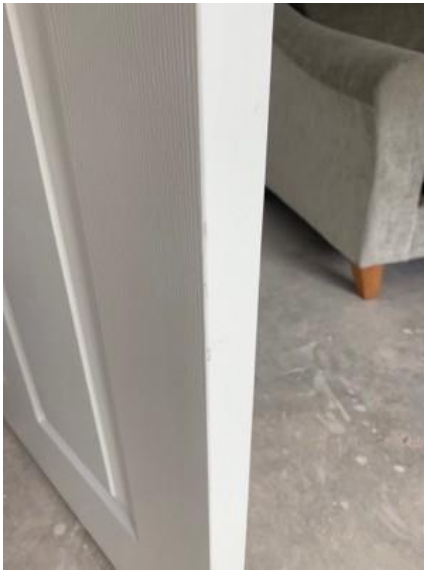
Snag 30

Multiple scuffs to door frame

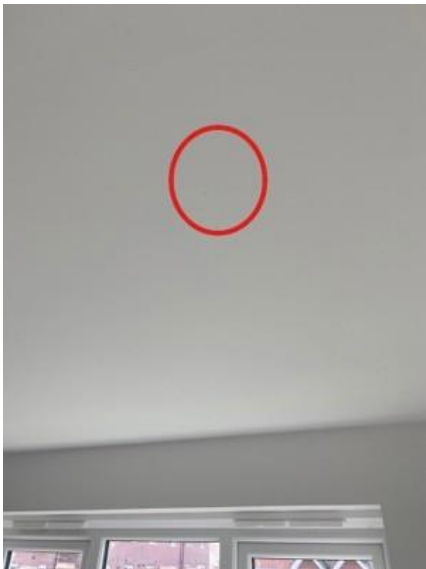
Snag 34

Dent in ceiling

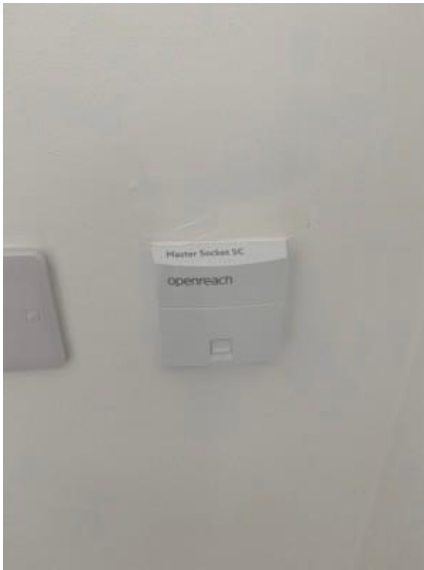
Snag 36

Make good around utility port

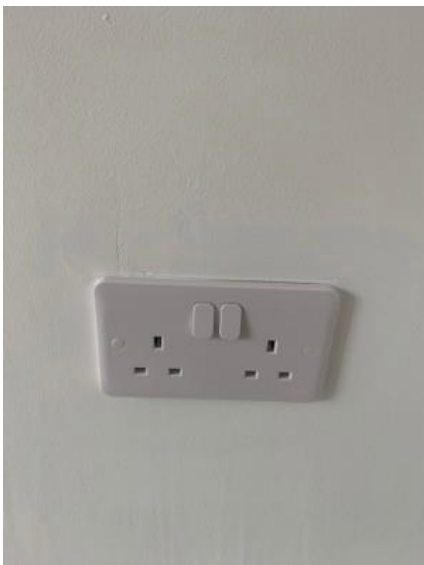
Snag 38

Make good around socket at north west wall

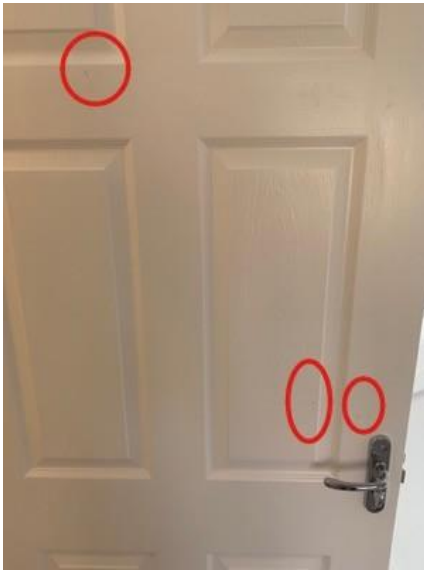
Snag 39

Multiple scuffs and dints to door

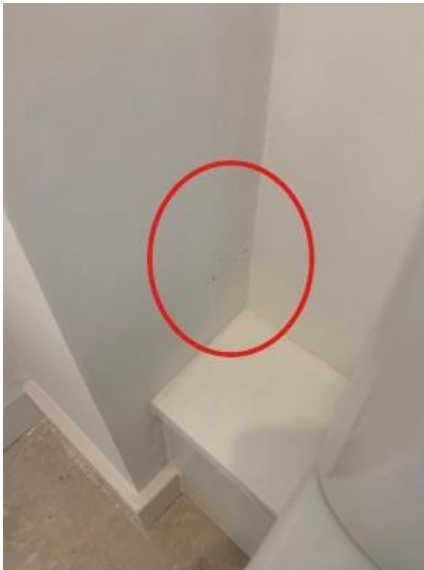
Snag 42

Make good

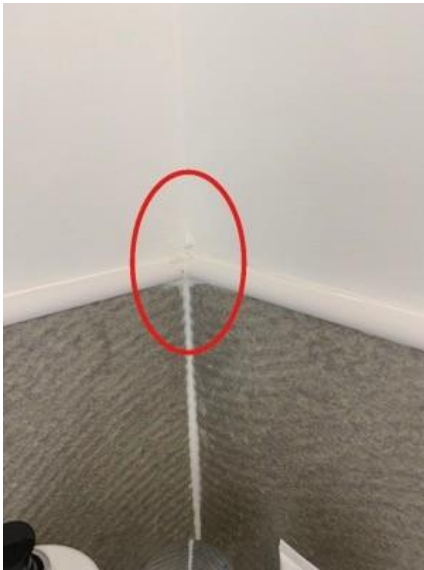
Snag 45

Make good paint finish and grouting

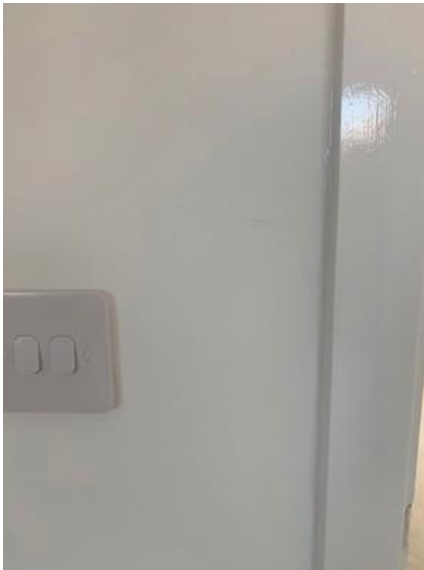
Snag 48

Scratch to paint

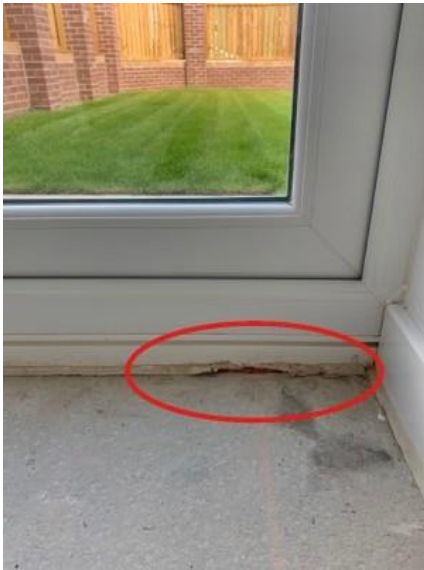
Snag 54

Continuous seal required

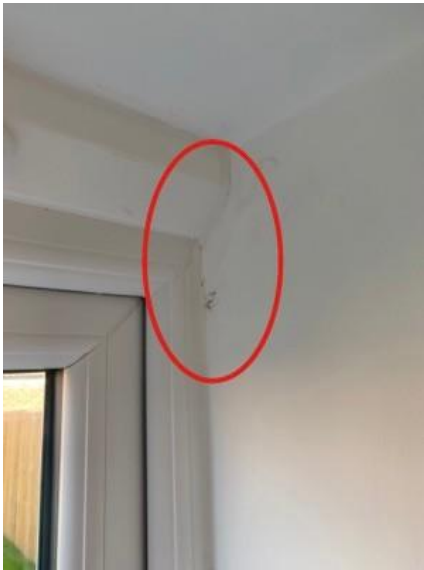
Snag 57

Make good

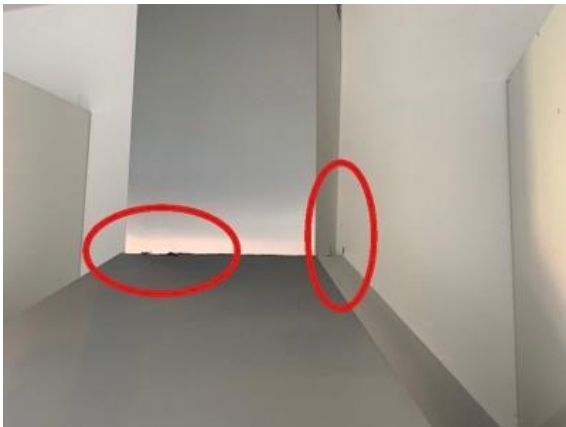
Snag 58

Fitting marks and tape visible

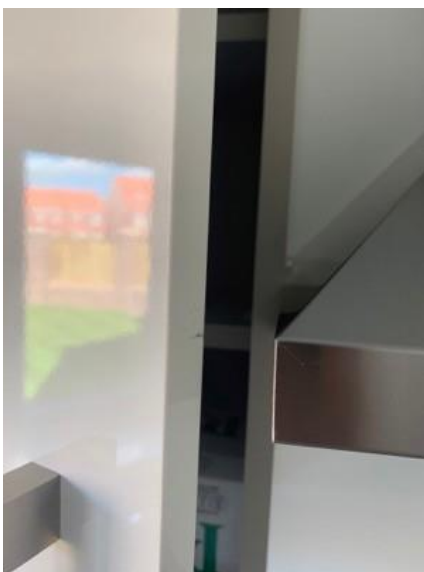
Snag 59

Door catching against extractor

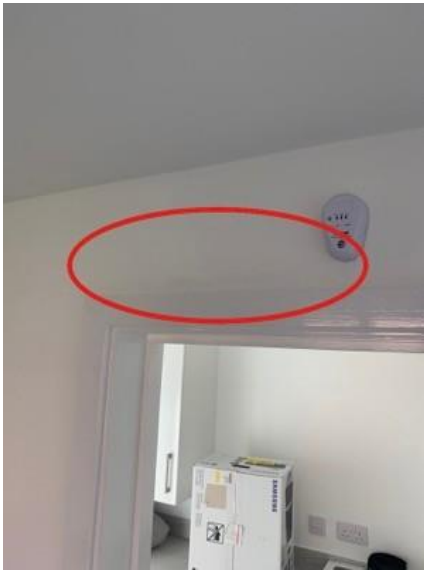
Snag 60

Grinning

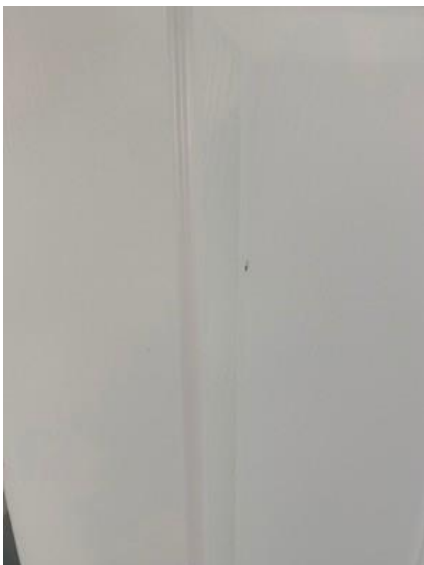
Snag 62

Chips and scuffs to door throughout

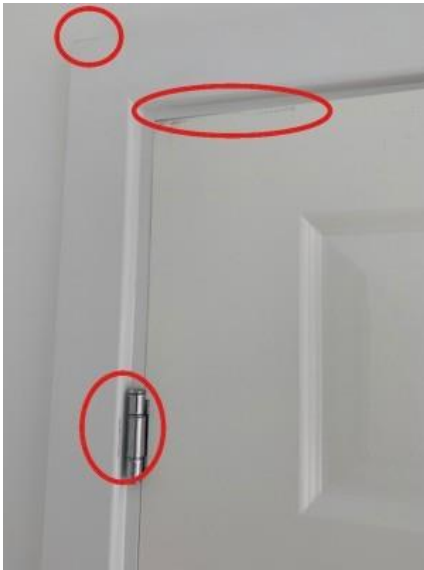
Snag 63

Chips and scuffs to doorthroughout

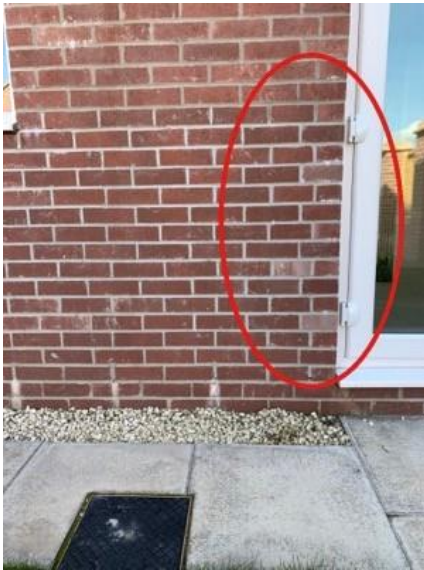
Snag 66

Inconsistent brick batch

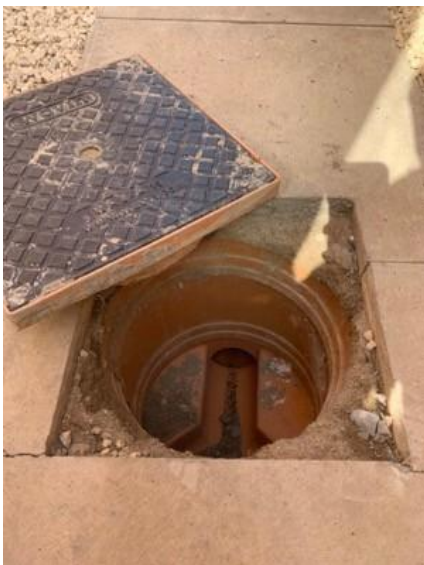
Snag 68

Drain cover incorrectly installed. Locking screw release not required for access.

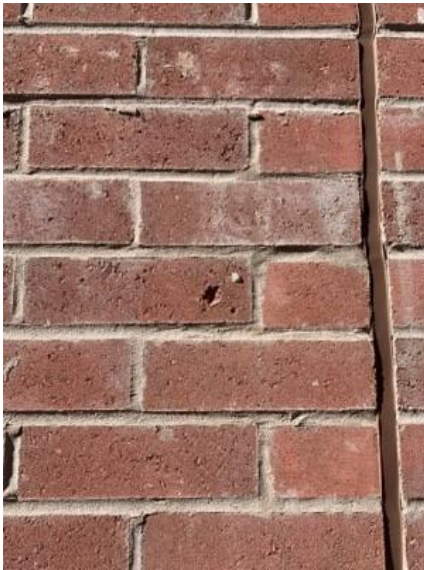
Snag 69

Dent in brick at west wall

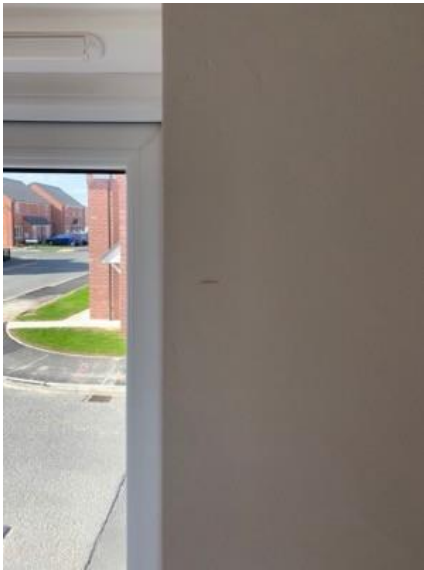
Snag 72

Scuff to paintwork

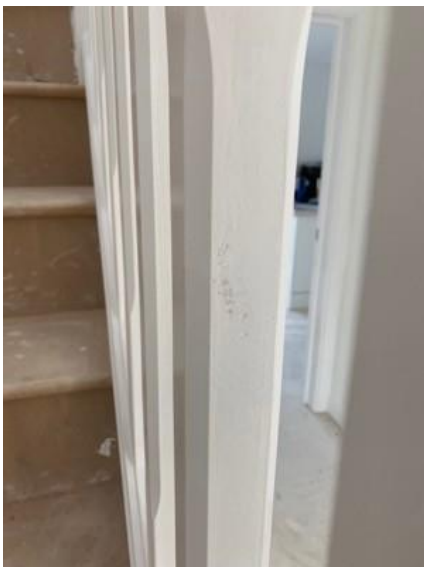
Snag 74

Make good

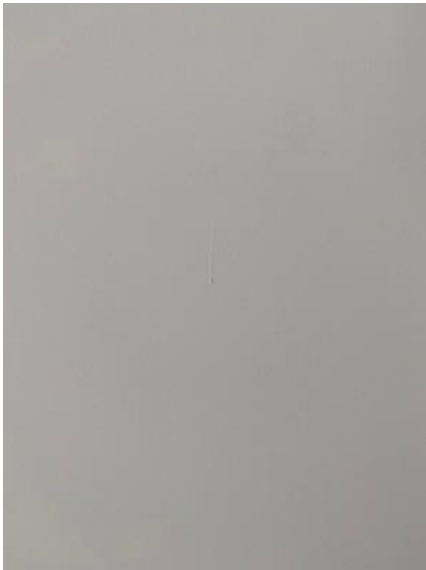
Snag 75

Paint run at north west wall

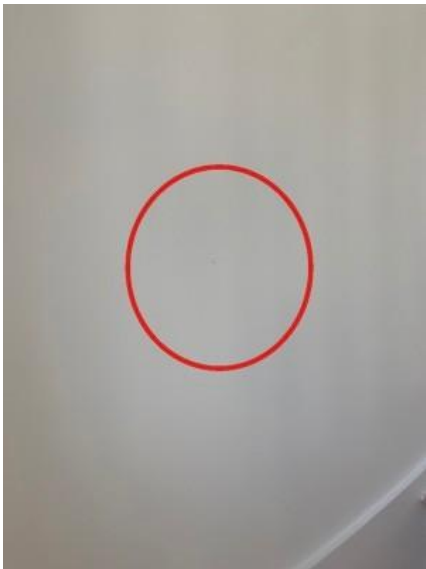
Snag 76

Paint scuff at north east wall

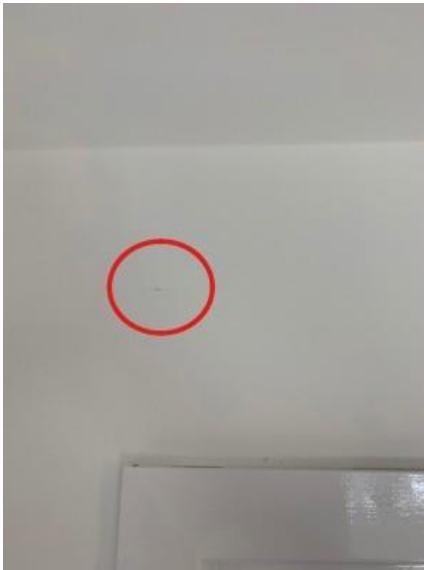
Snag 78

Paint mark above larger north bedroom

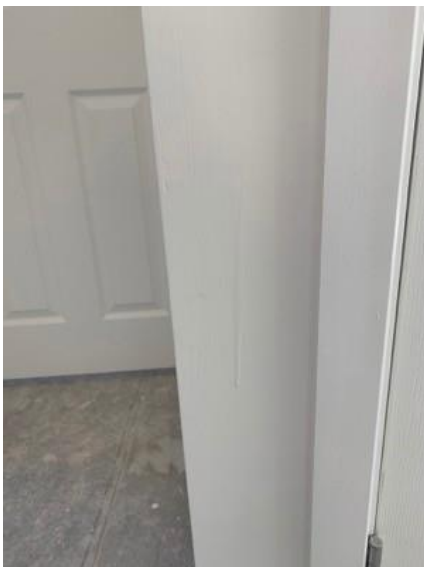
Snag 80

Paint run

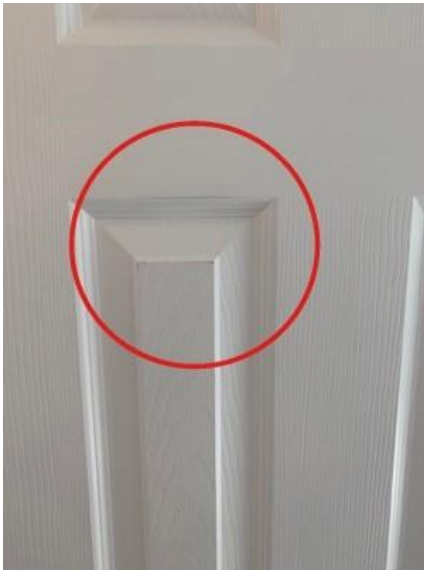
Snag 97

Scuff marks to storage cupboard

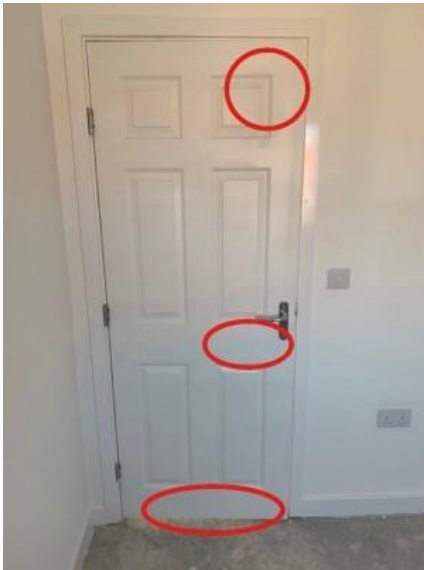
Snag 83

Scuffs and dints in door throughout

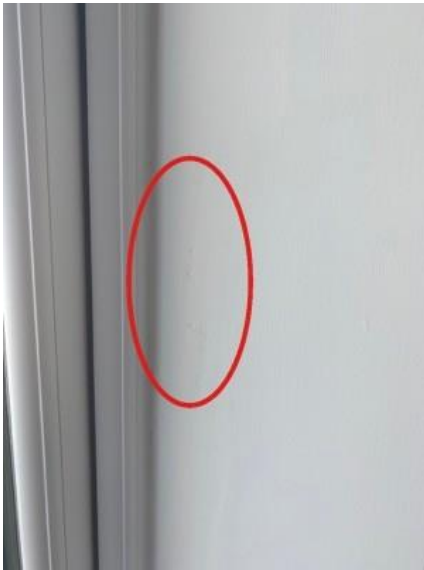
Snag 86

Make good to right of window recess

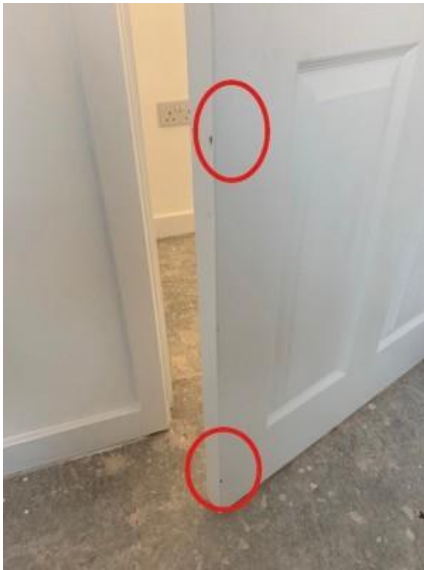
Snag 89

Paint chips

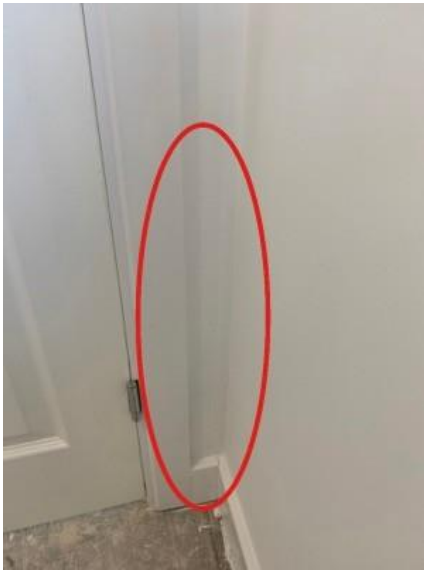
Snag 92

Make good

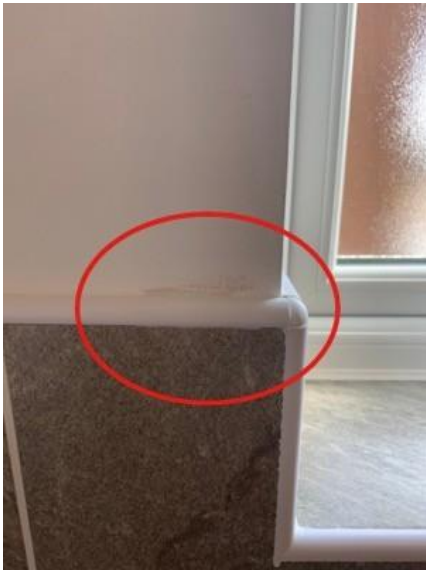
Snag 95

Inconsistent paint finish

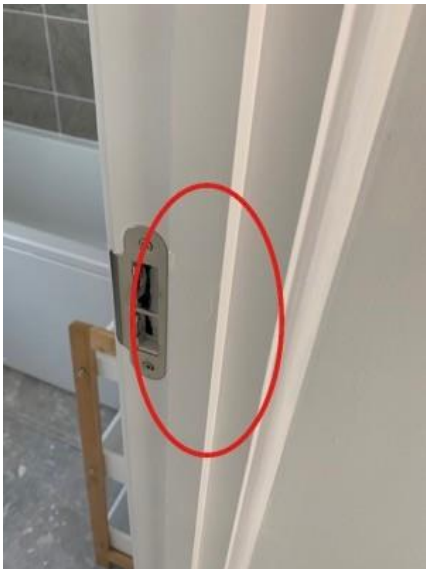
Snag 96

Matt paint used to touch up gloss finish

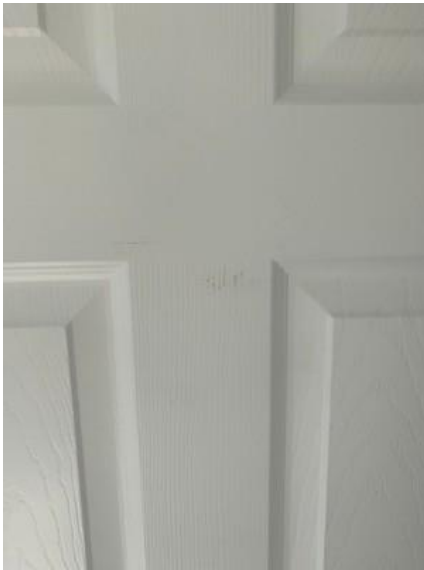
Snag 99

Scuff on en-suite door

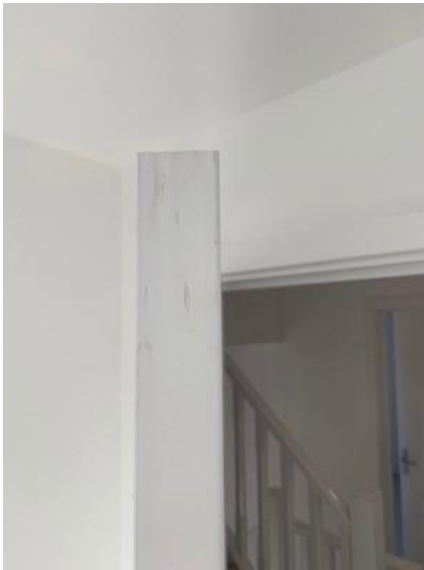
Snag 102

Damage to door

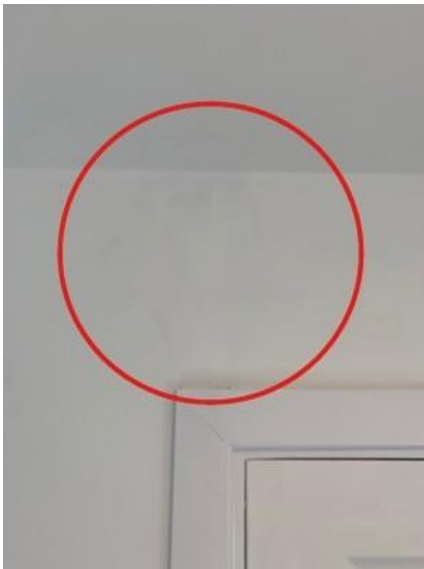
Snag 103

Grinning

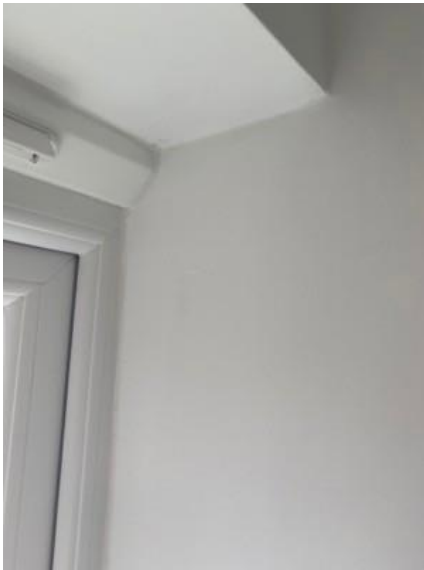
Snag 105

Paint run

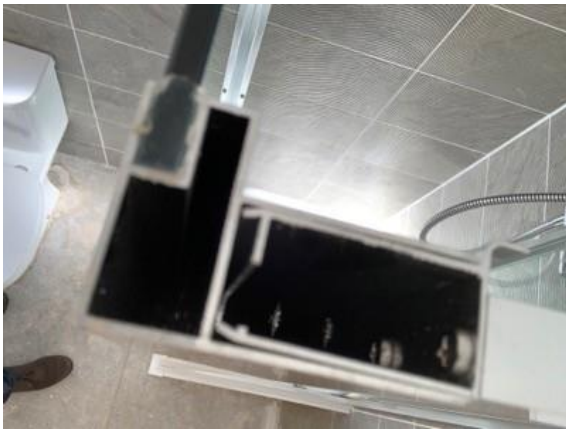
Snag 106

No top caps fitted. Vulnerable to water ingress

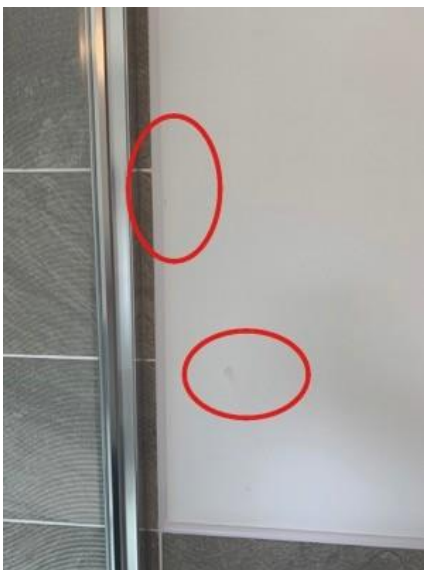
Snag 107

Marks to paintwork

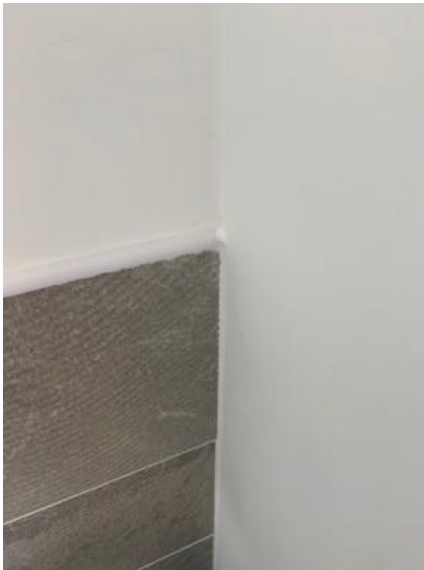
Snag 108

Make good bullnose at east corner

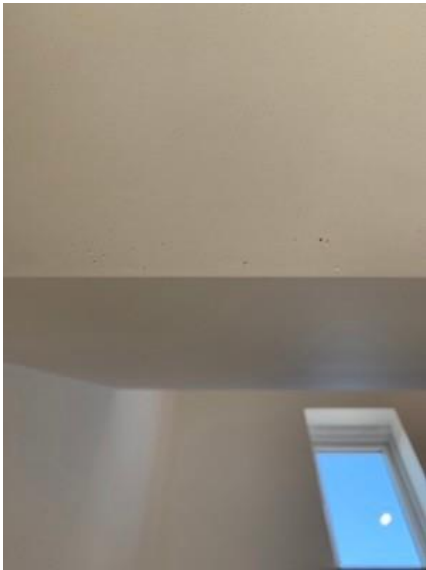
Snag 111

Make good

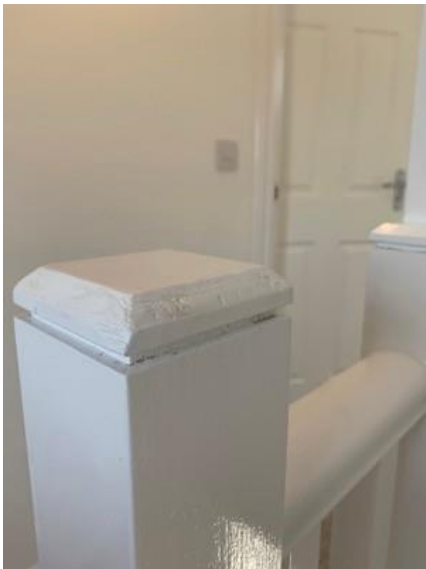
Snag 112

Make good

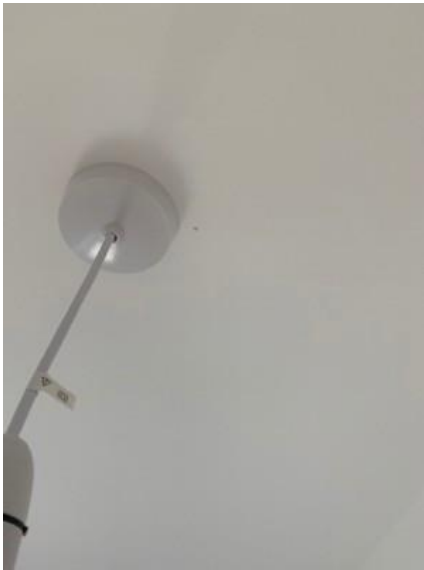
Snag 114

Make good at entrance to master bedroom

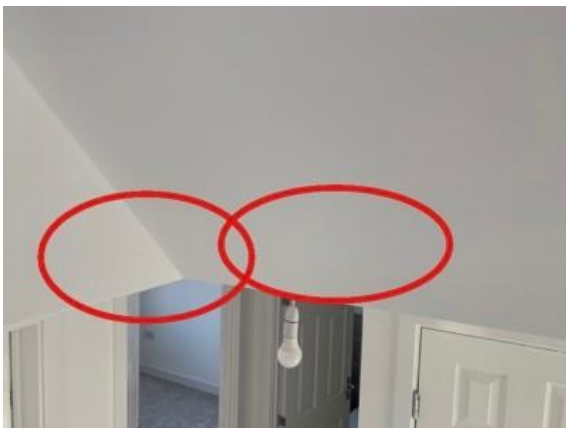
Snag 116

Make good

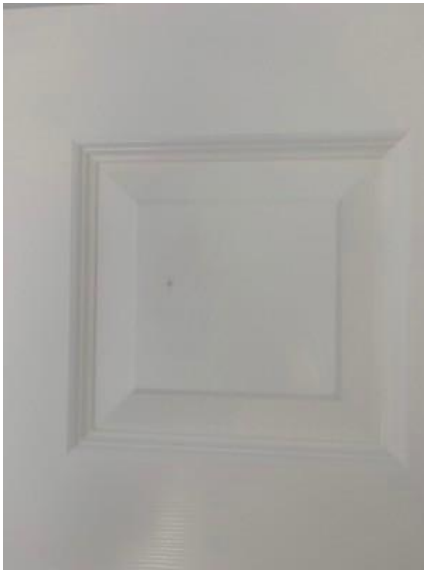
Snag 117

Scuff marks on door entrance door

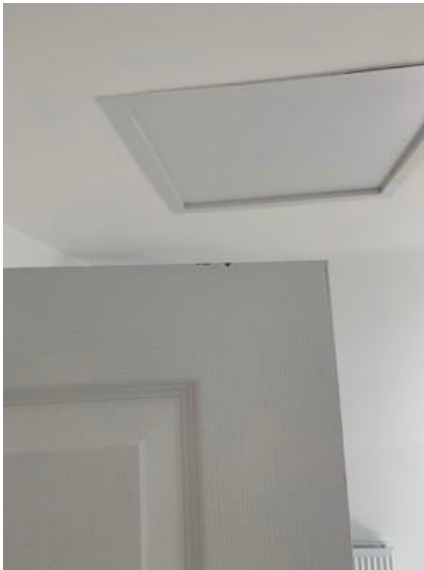
Snag 120

Damage to storage cupboard door

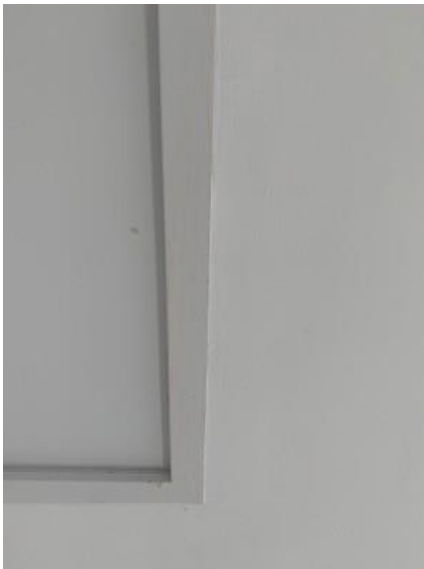
Snag 121

Staining on entrance hatch

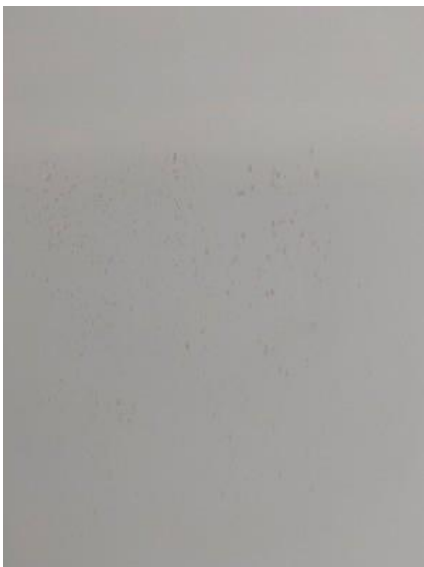
Snag 122

Make good stains on ceiling

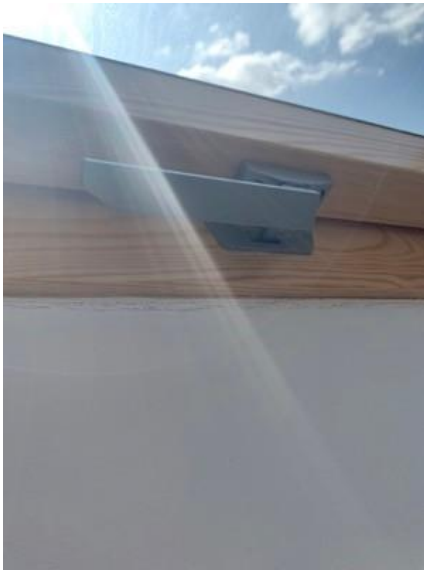
Snag 123

Make good on window recess

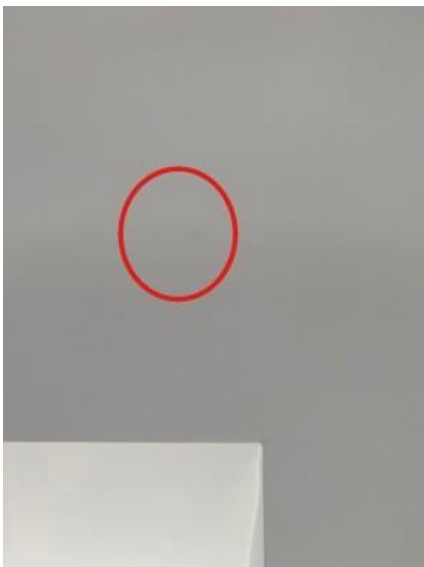
Snag 125

Paint run at north window

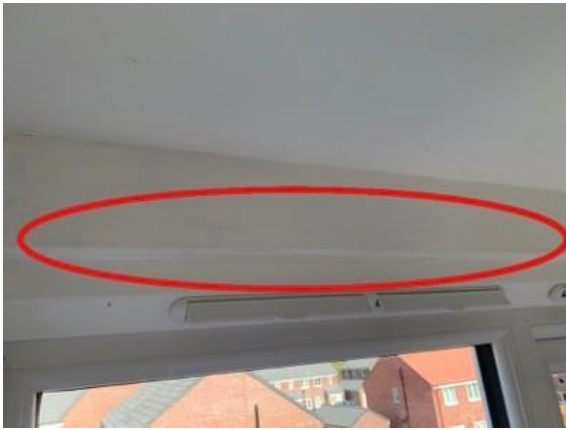
Snag 126

Make good above north window

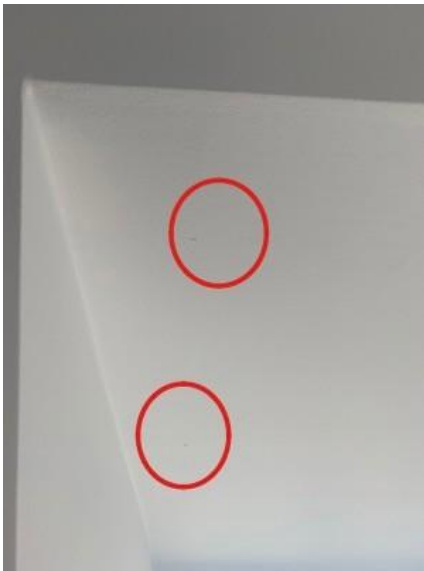
Snag 127

Paint runs at north window

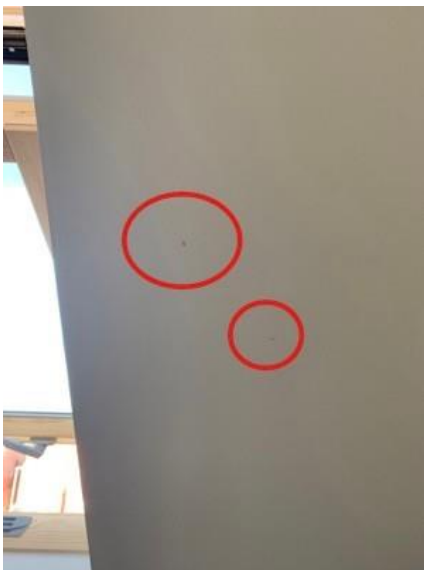
Snag 128

Make good

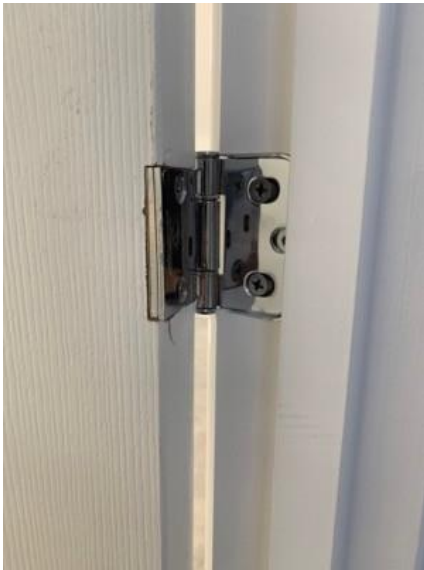
Snag 129

Door damaged from hinge installation

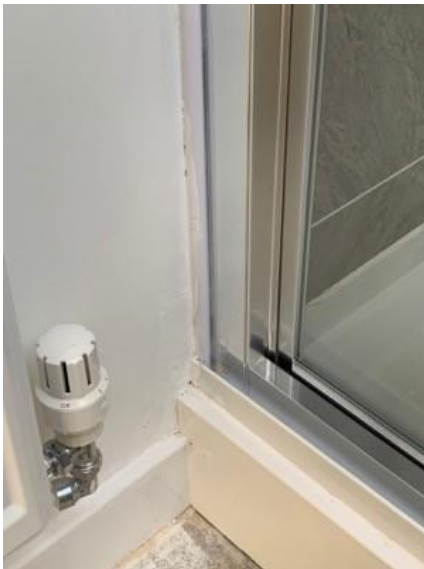
Snag 130

Make good paint on bullnose
