Example Report

Prepared for Sarah Snag

Client	Sarah Snag
Instruction	26/08/2020
Address	27, Snag Close, Snagchester, SN3 AG
Builder	Example Homes
Development Name	Snag Tree Grange
Weather	Fair and sunny
Inspector	Phil Lucas
Inspection Date	19/08/2020

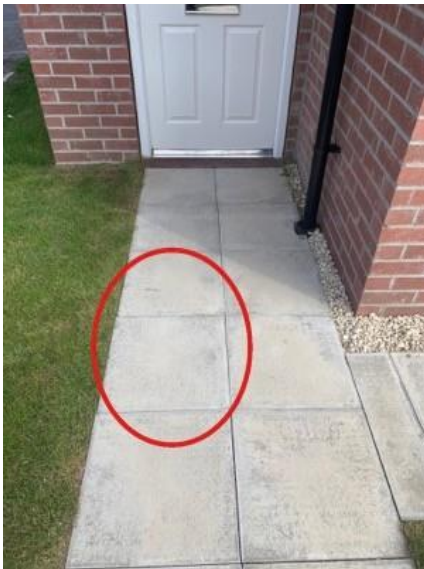
Snag 5

Loose slap

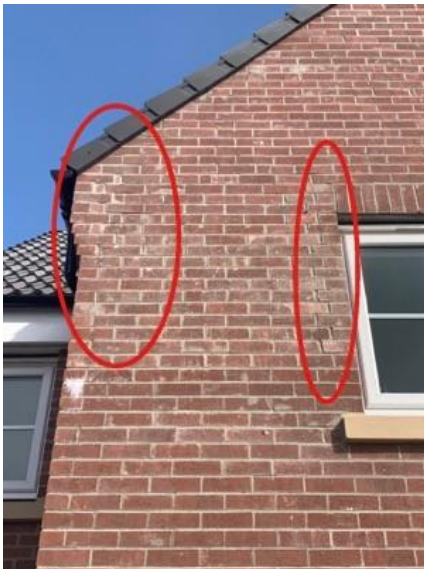
Snag 8

Make good pointing and lay

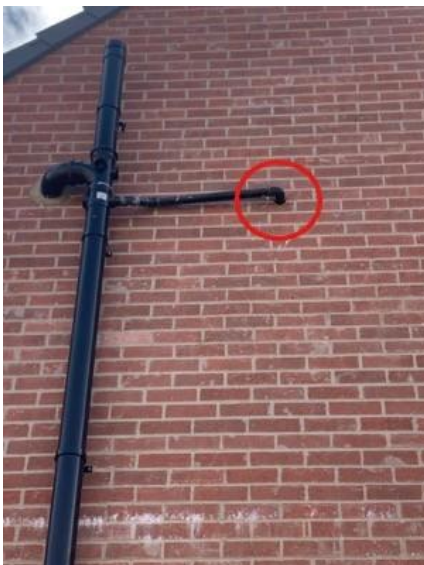
Snag 9

Continuous seal required. Risk of infestation.

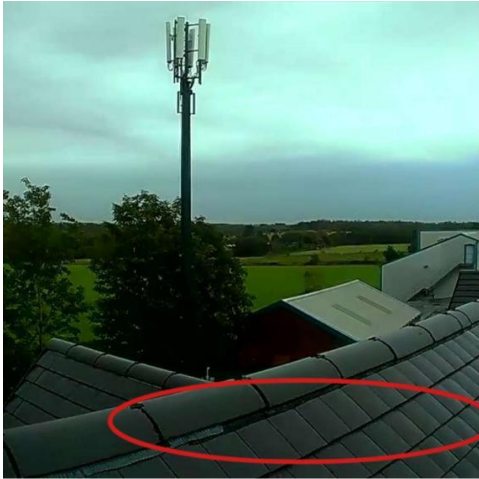
Snag 10

Roof ridging tile DPC inconsistent

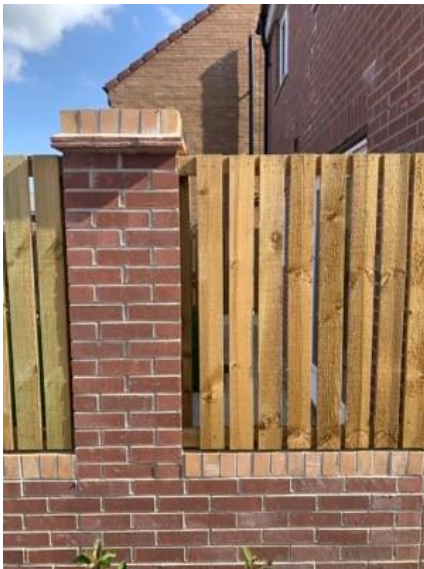
Snag 135

Inconsistent panel spacing

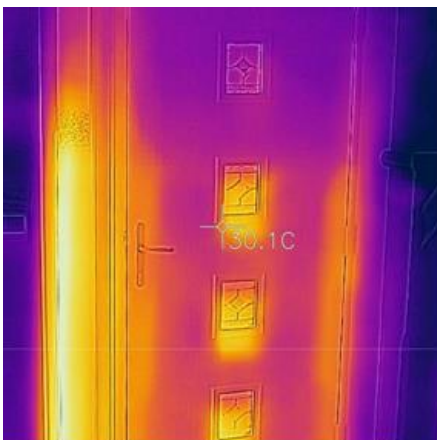
Snag 14

Thermal Performance
as expected

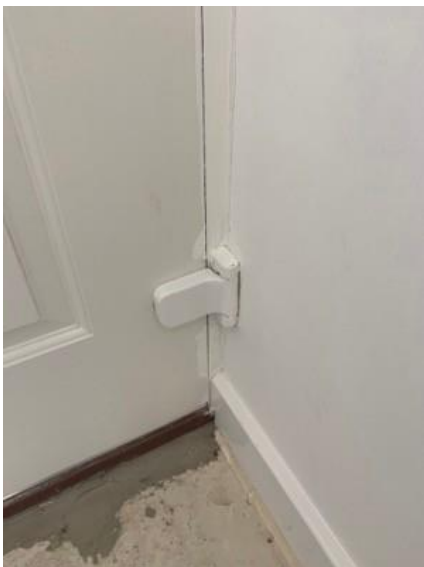
Snag 17

Paint on door and excessive paint on all door hinges

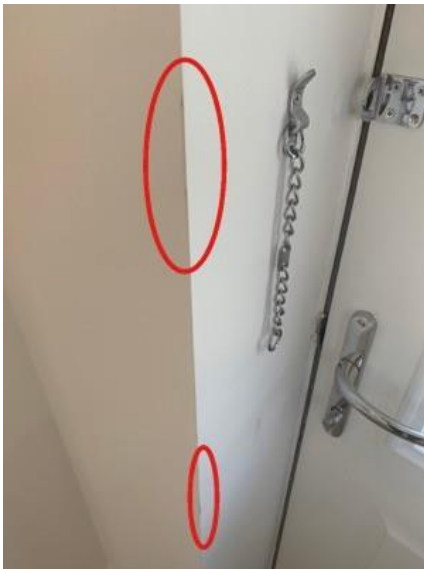
Snag 19

Corner beading visible

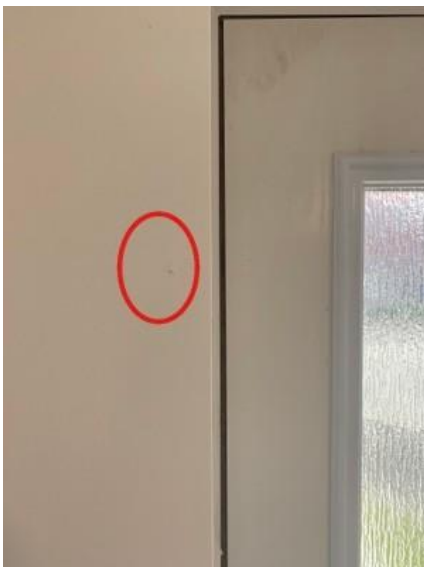
Snag 20

Paint run

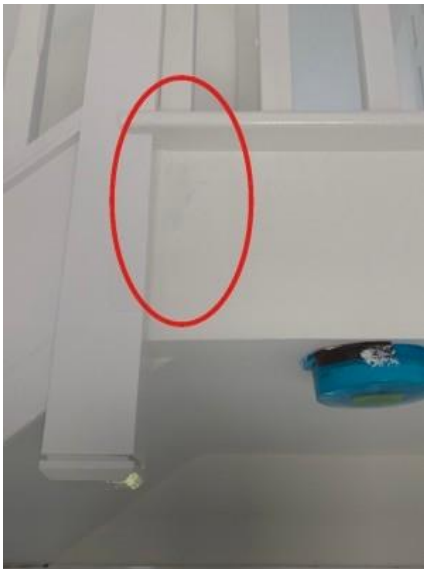
Snag 22

Paint grinning

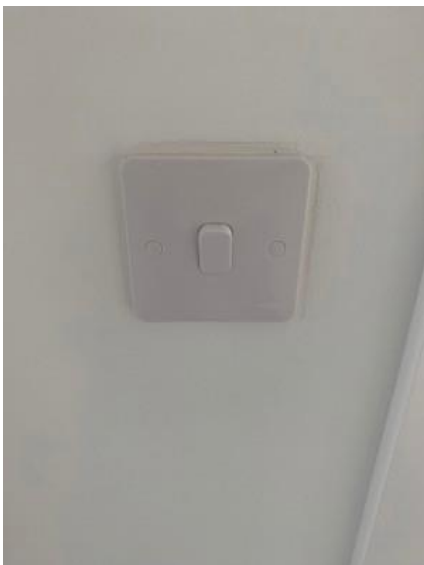
Snag 23

Make good around light switch on east wall

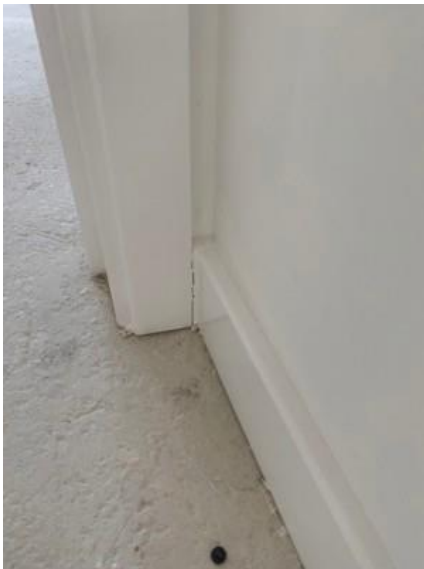
Snag 25

Make good at butt joint

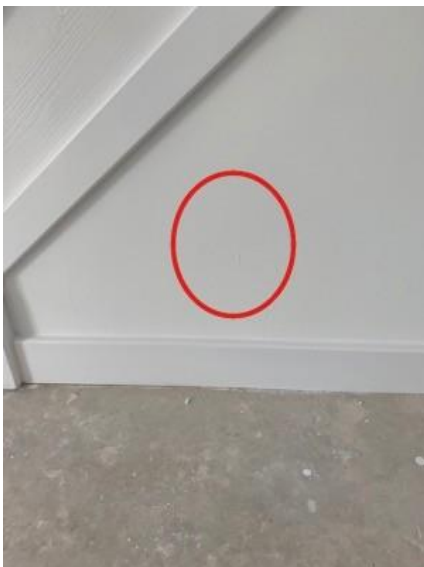
Snag 26

Paint run

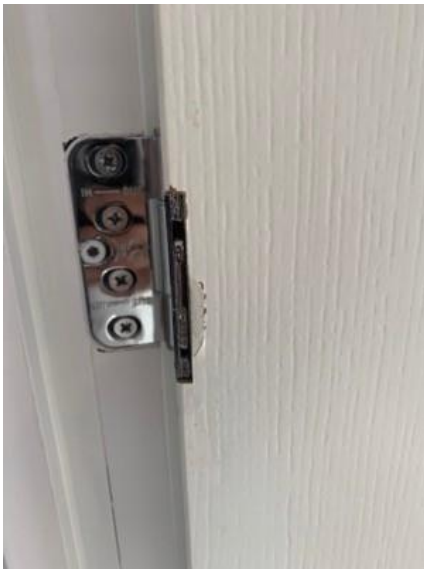
Snag 28

Damage to living room door when hinges fitted x3

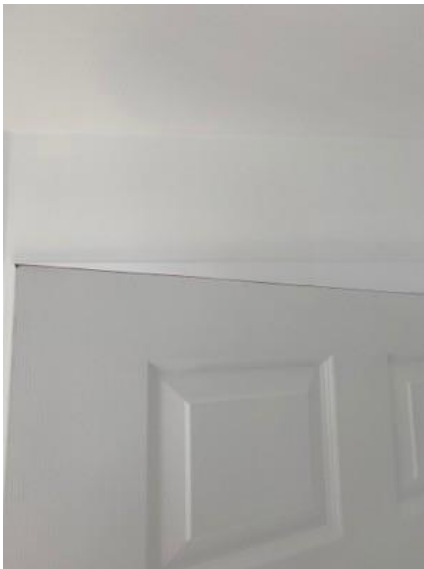
Snag 31

Incomplete paint finish

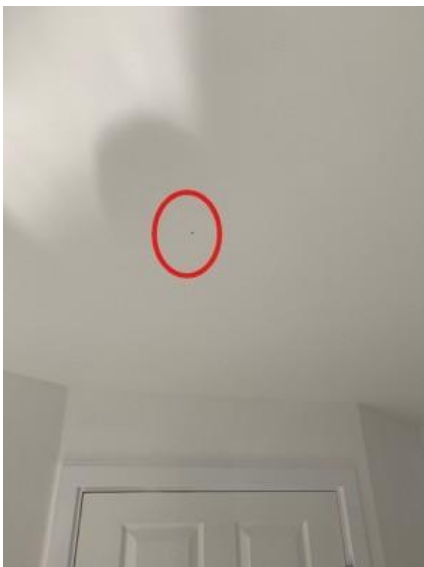
Snag 32

Dent in plasterboard

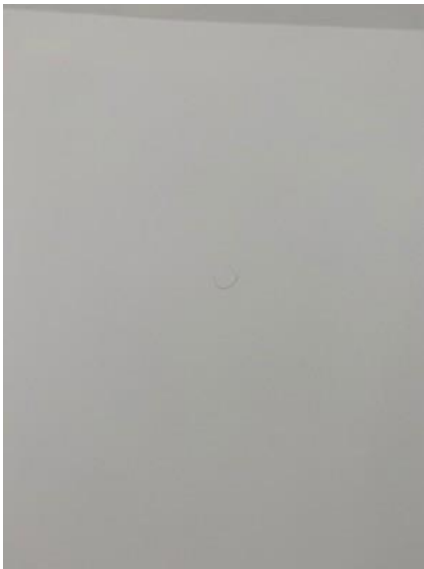
Snag 37

Plaster damage at north east wall

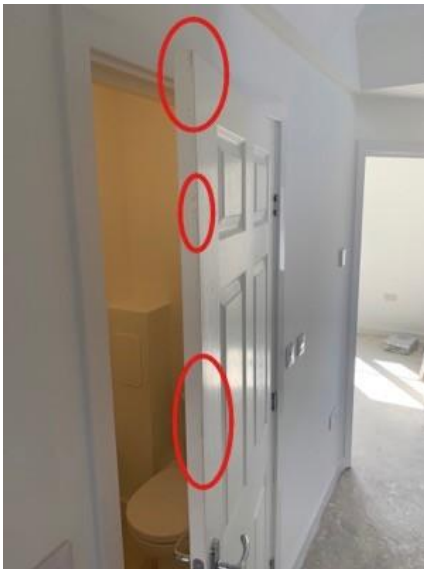
Snag 40

Multiple scuffs and dints to door

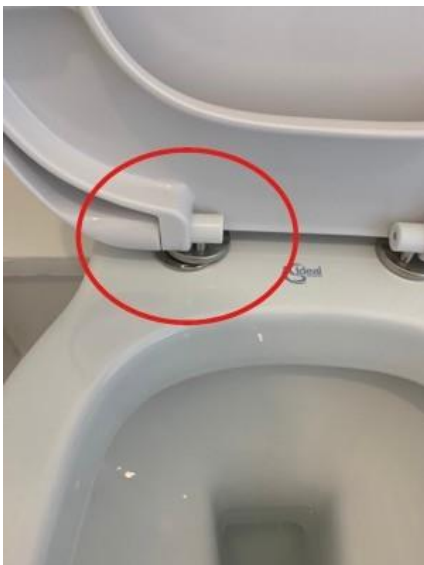
Snag 41

Incorrect instillation

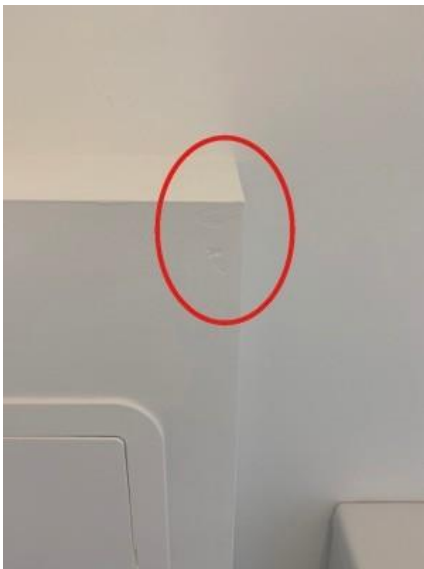
Snag 43

Make good

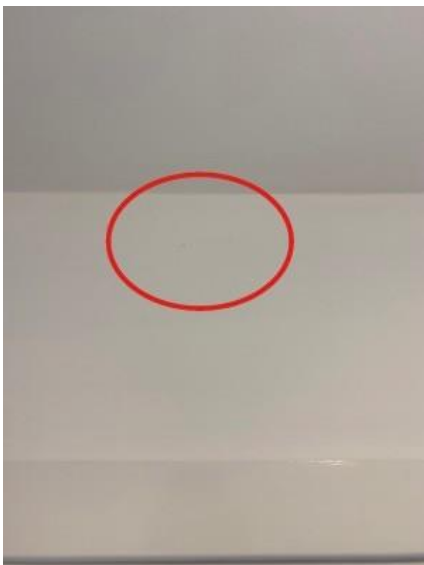
Snag 44

Damage to plasterboard

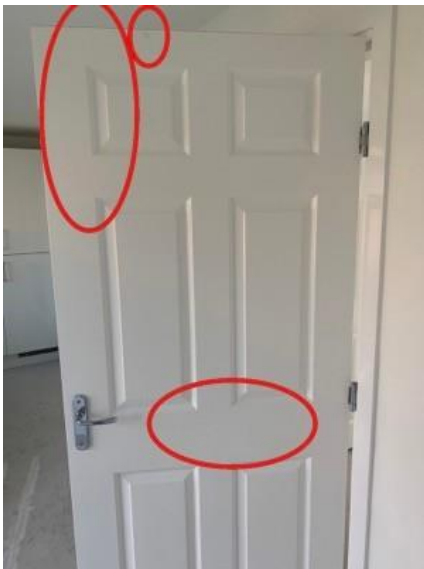
Snag 46

Scuffs and paint speckle throughout

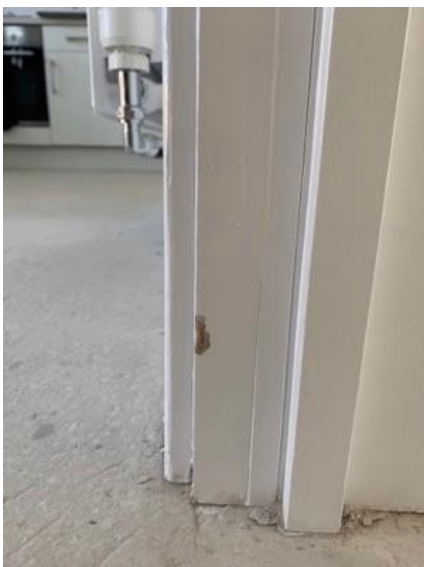
Snag 47

Damage to door frame

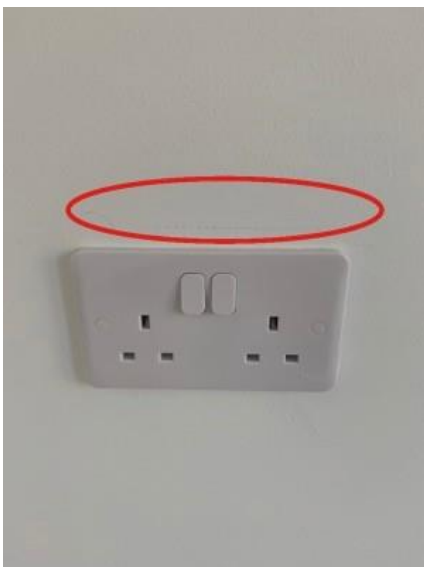
Snag 50

Make good at west wall

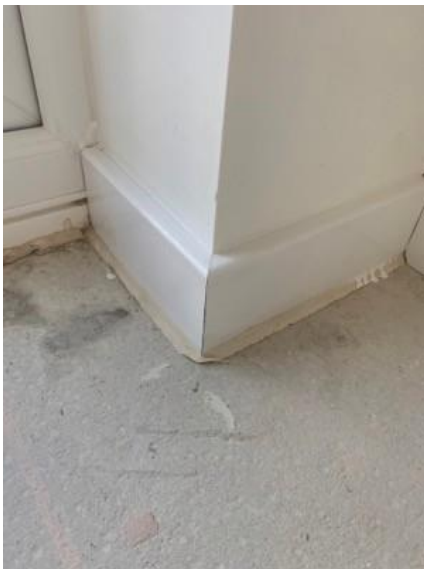
Snag 52

Make good miter at east corner

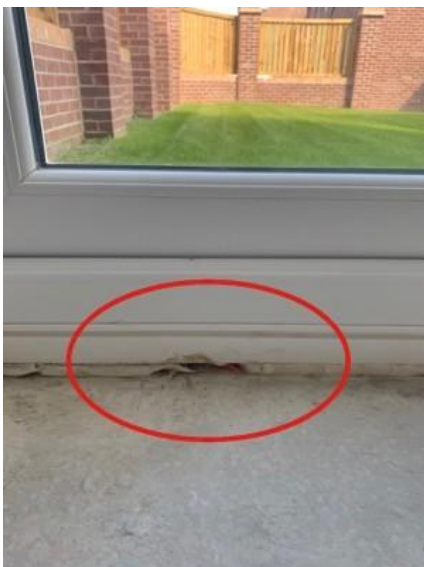
Snag 53

Continuous seal required

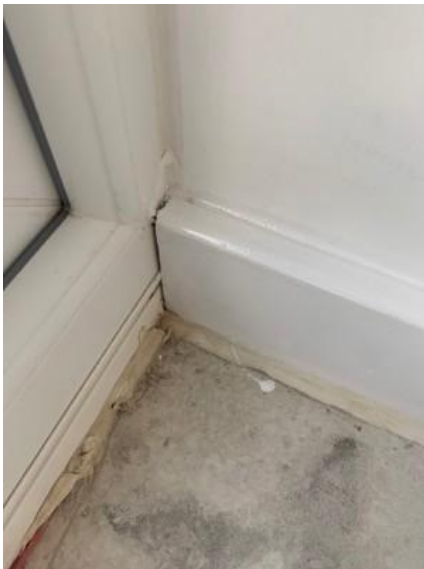
Snag 55

Make good butt joints at french doors

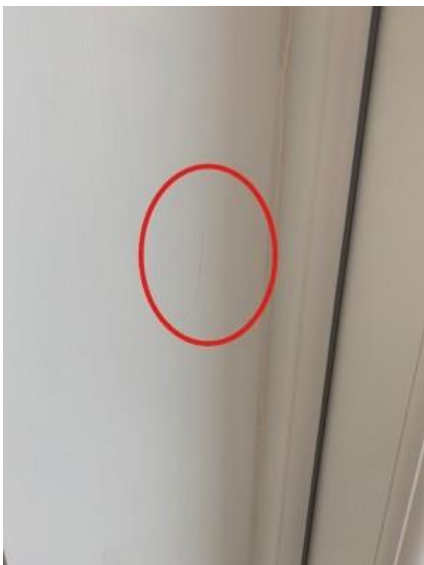
Snag 56

Paint run at north corner

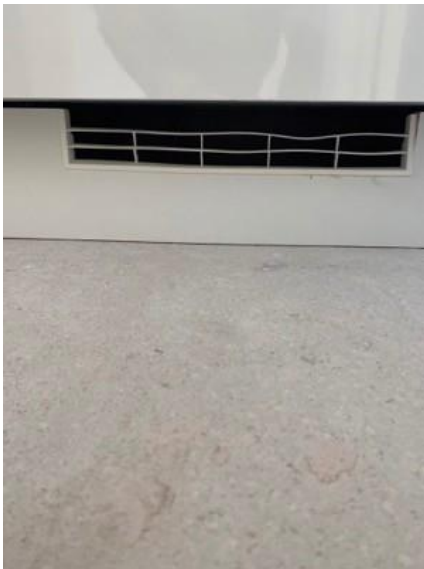
Snag 61

Vent damaged

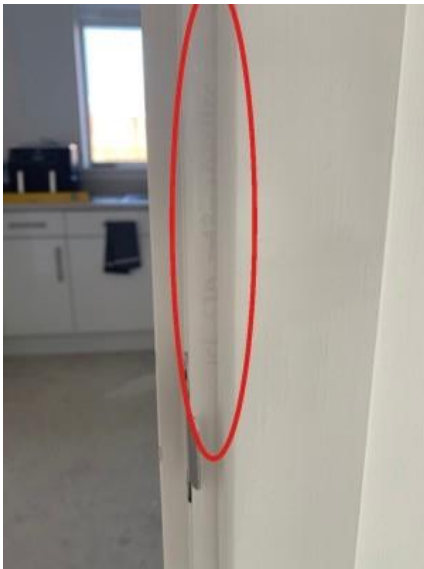
Snag 64

Fitting marks visible

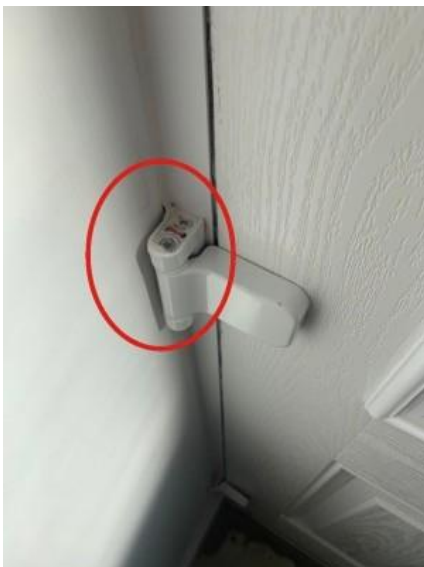
Snag 65

Hinge Caps not fitted x3

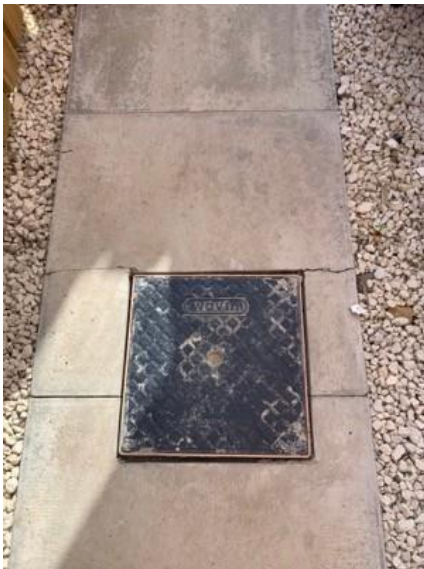
Snag 67

Damaged slab

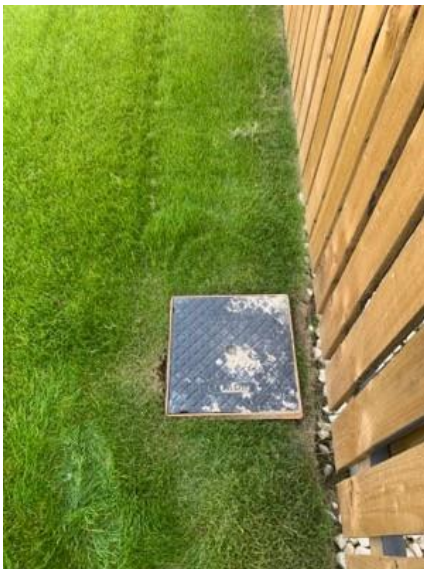
Snag 70

Drain cover not correctly installed

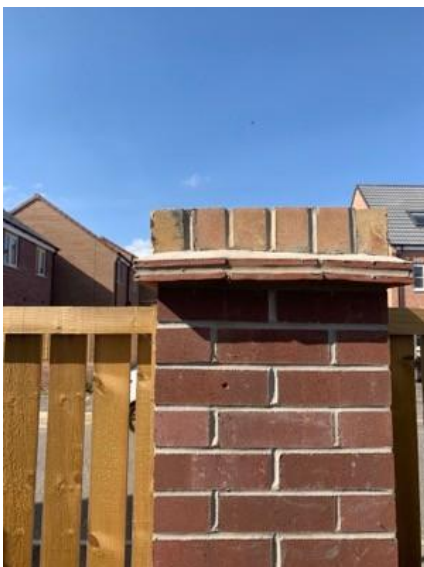
Snag 71

Insufficient mortar

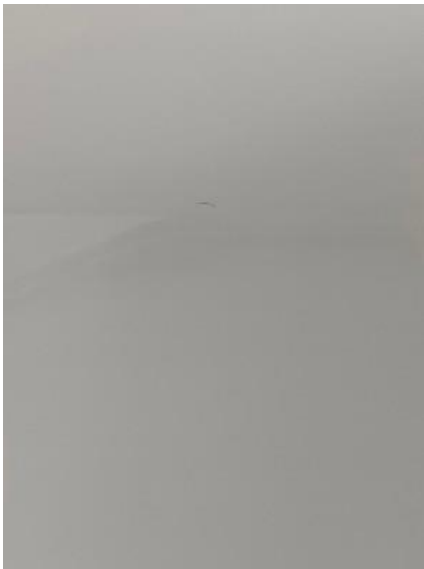
Snag 73

Plaster damage

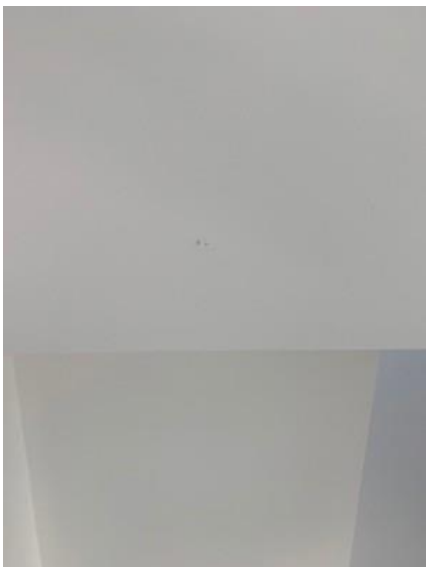
Snag 77

Make good ceiling at landing

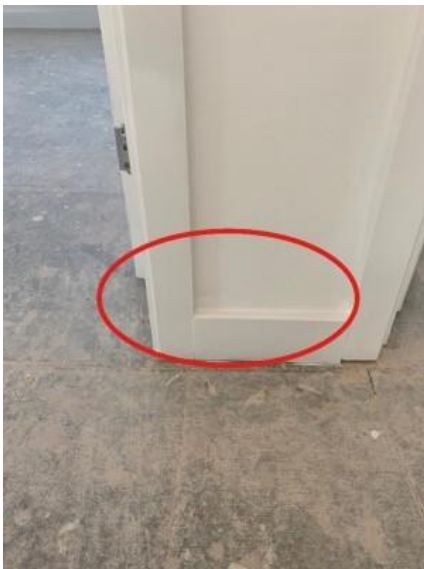
Scuff marks to storage cupboard

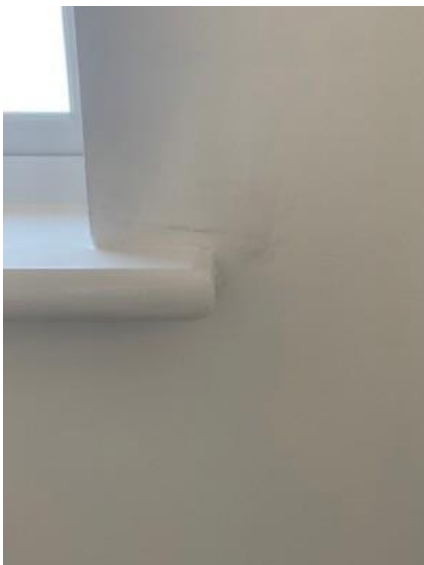
Snag 84

Location: North Facing Bedroom

Marks on east facing wall

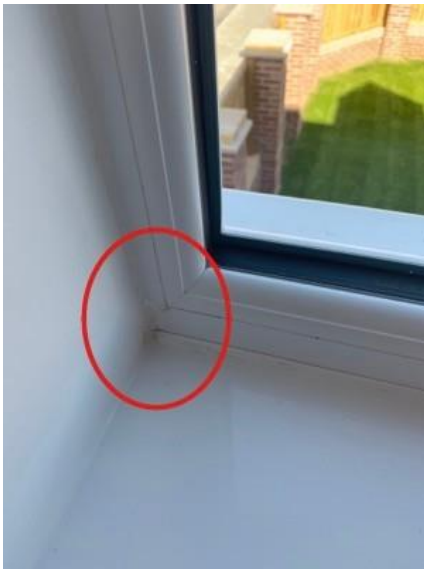
Snag 86

Location: North Facing Bedroom

Make good to right of window recess

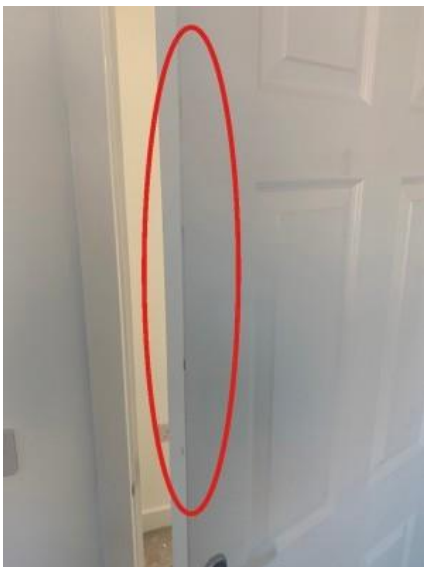
Snag 87

Location: North Facing Bedroom

Excessive paint

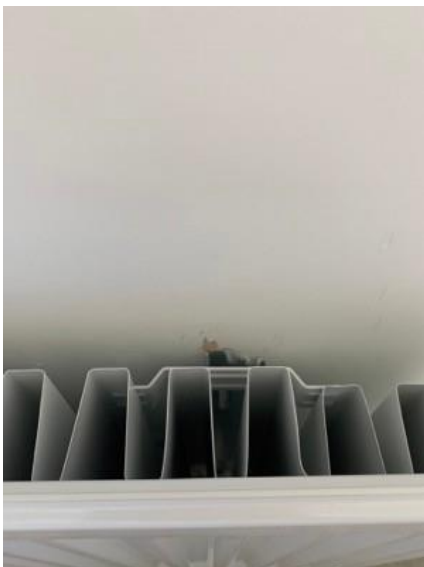
Snag 90

Location: North East Facing Bedroom

Make good at east corner

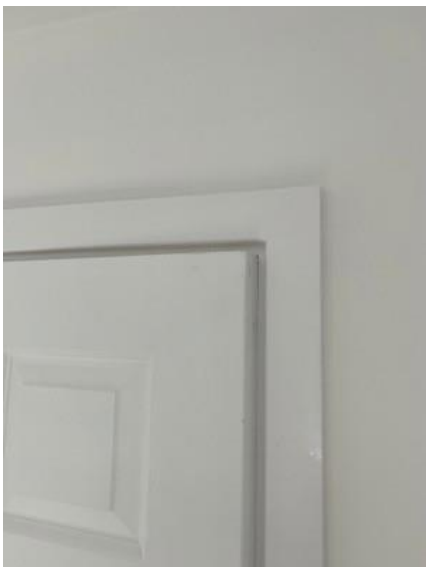
Snag 96

Location: Family Bathroom

Matt paint used to touch up gloss finish

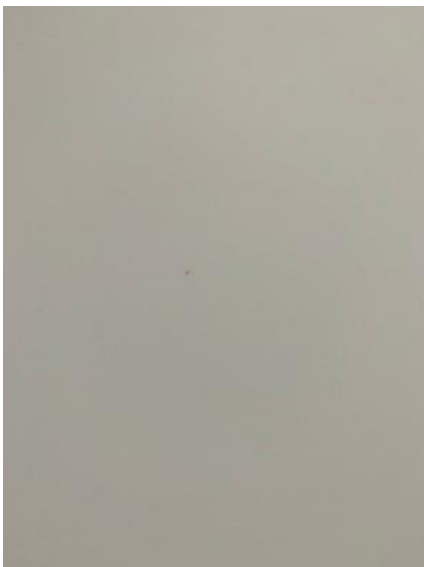
Snag 100

Location: South Facing Bedroom

Marks on ceiling

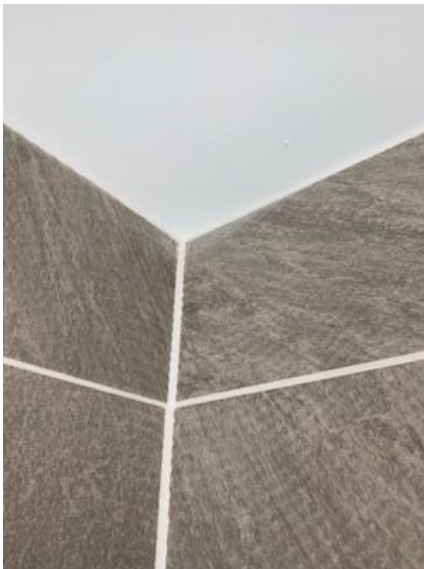
Snag 108

Location: South Facing Bedroom En-suite

Make good bullnose at east corner

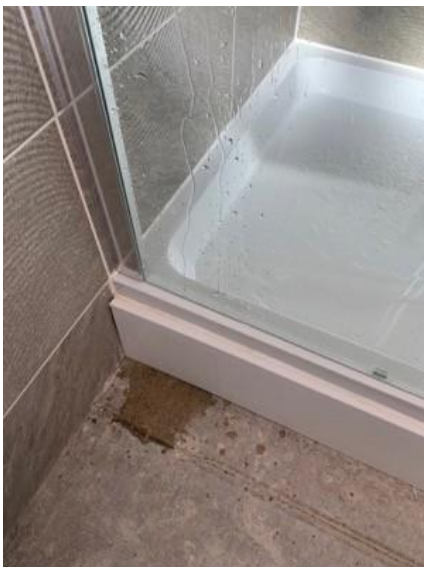
Snag 109

Location: South Facing Bedroom En-suite

Make good at north corner

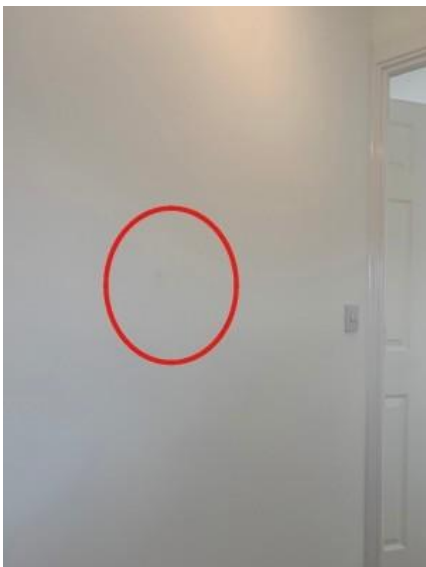
Snag 112

Location: Second Floor Staircase

Make good

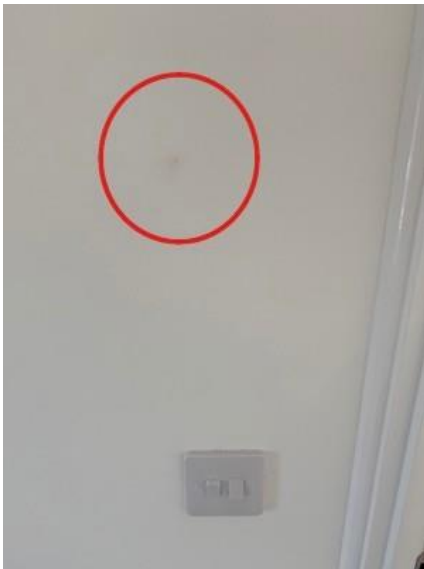
Snag 114

Location: Second Floor Staircase

Make good at entrance to master bedroom

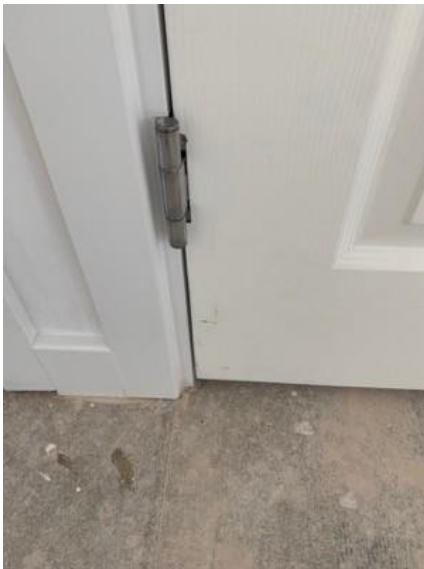
Snag 117

Location: Master Bedroom

Scuff marks on door entrance door

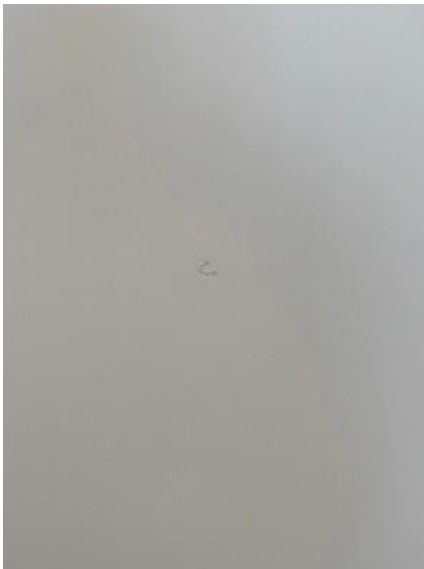
Snag 123

Location: Master Bedroom

Make good on window recess

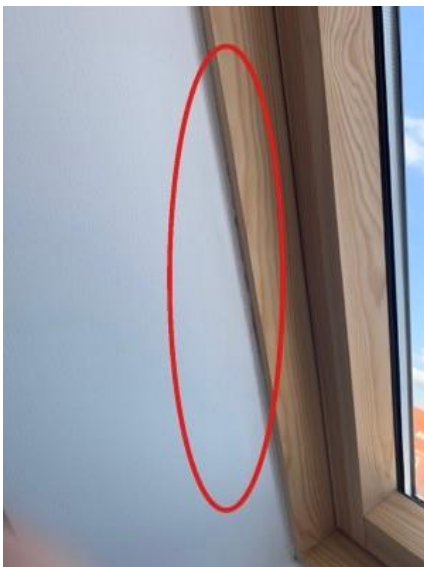
Snag 130

Location: Master Bedroom En-suite

Make good paint on bullnose

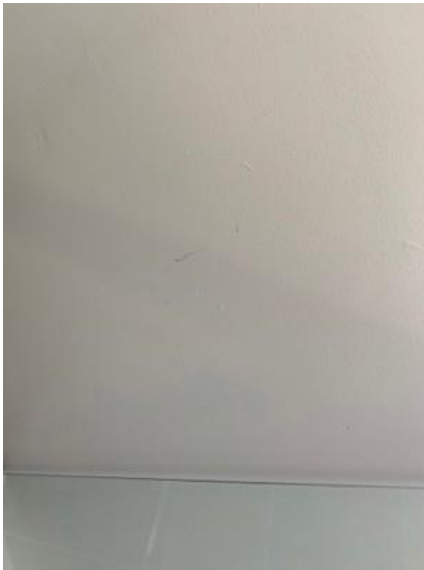
Snag 131

Location: Master Bedroom En-suite

Make good around skylight throughout

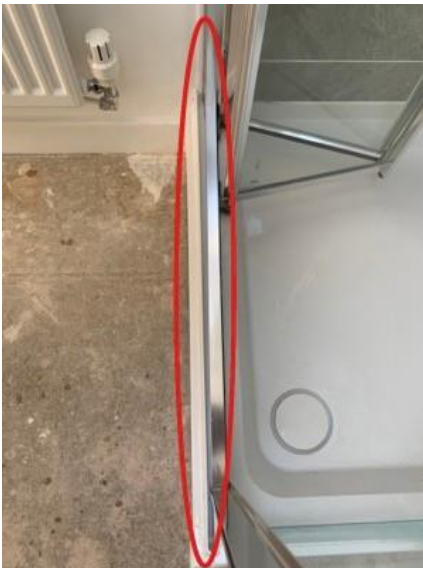
Snag 132

Location: Master Bedroom En-suite

Make good above showertray
